Appendix D – Abridged Hazardous Materials

Executive Summary of the Hazardous Materials Assessment and the Phase I Environmental Site Assessments

**K. I. SAWYER AIR FORCE BASE,
MARQUETTE COUNTY, MICHIGAN
AUGUST 1995**

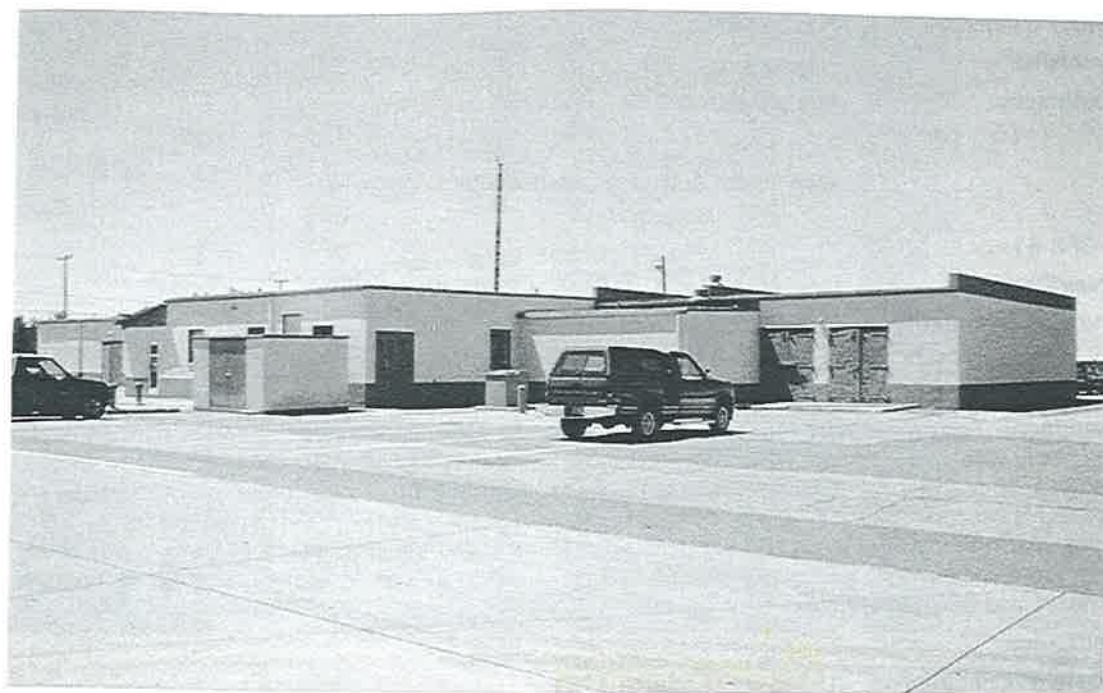
Significance:
 Date of Construction: 1956; alterations in 1961
 Architect/Builder: Unknown
 Context: Associated with Air Defense Command alert operations from 1956-1985 as part of the Cold War strategy of fighter aircraft interception against nuclear air attack by the Soviet Union. Used to store rockets carried on the interceptor fighter aircraft.
 Bibliographic Reference: Real Property forms, As-built drawings

Building 403; Negative No. 3:2; Date 1994; View south and east facades/facing northwest

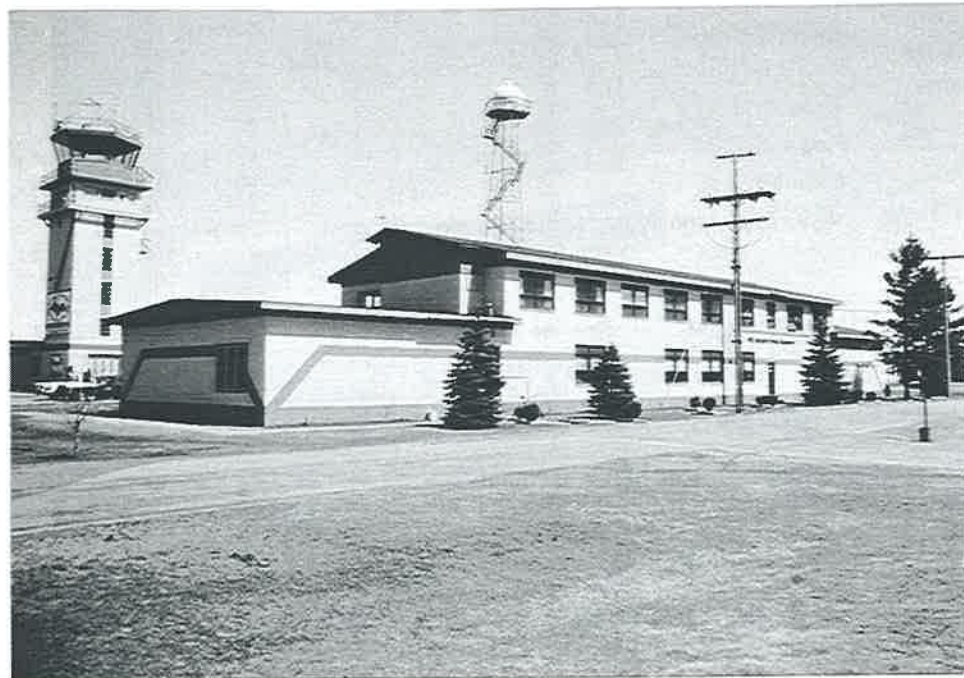
Significance:
 Date of Construction: 1956; alterations 1958, 1963, 1980s?
 Architect/Builder: Giffels & Vallet, Inc., L. Rossetti, Detroit, Michigan, for the U.S. Army Corps of Engineers, Detroit District.
 Context: Associated with Air Defense Command alert operations from 1956-1985 as part of the Cold War strategy of fighter aircraft interception against nuclear air attack by the Soviet Union. Used as a crew readiness building with support facilities for the fighter alert system.
 Bibliographic Reference: Real Property forms, As-built drawings

Building 426; Negative No. 2:33; Date 1994; View south and west facades/facing northeast

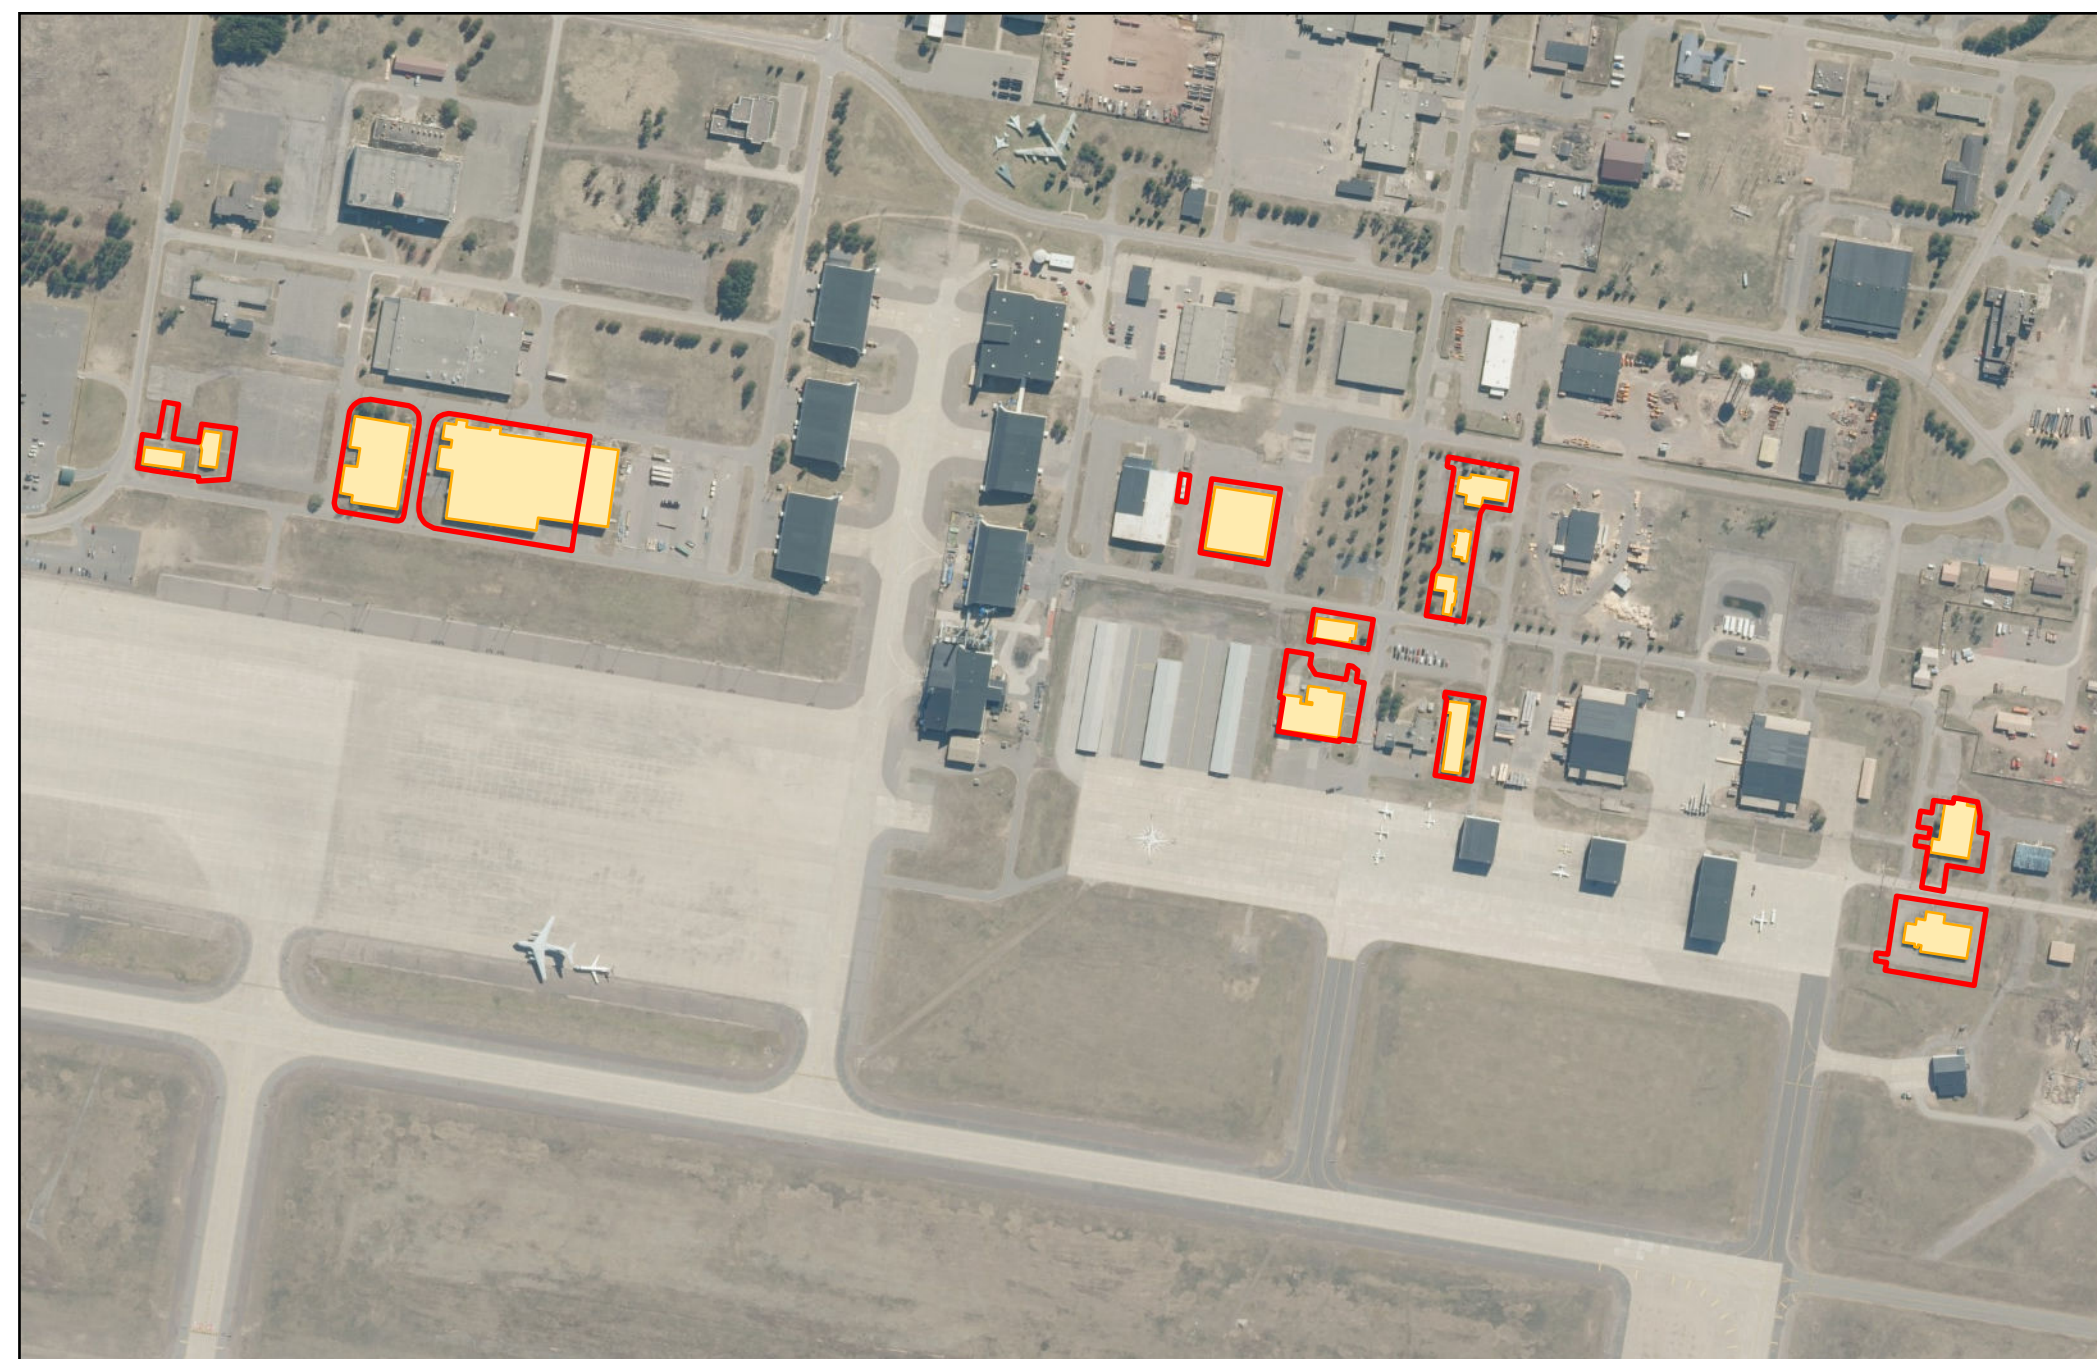
Figure 3
Project Area

- Legend**
- Buildings
 - Limits of Demolition

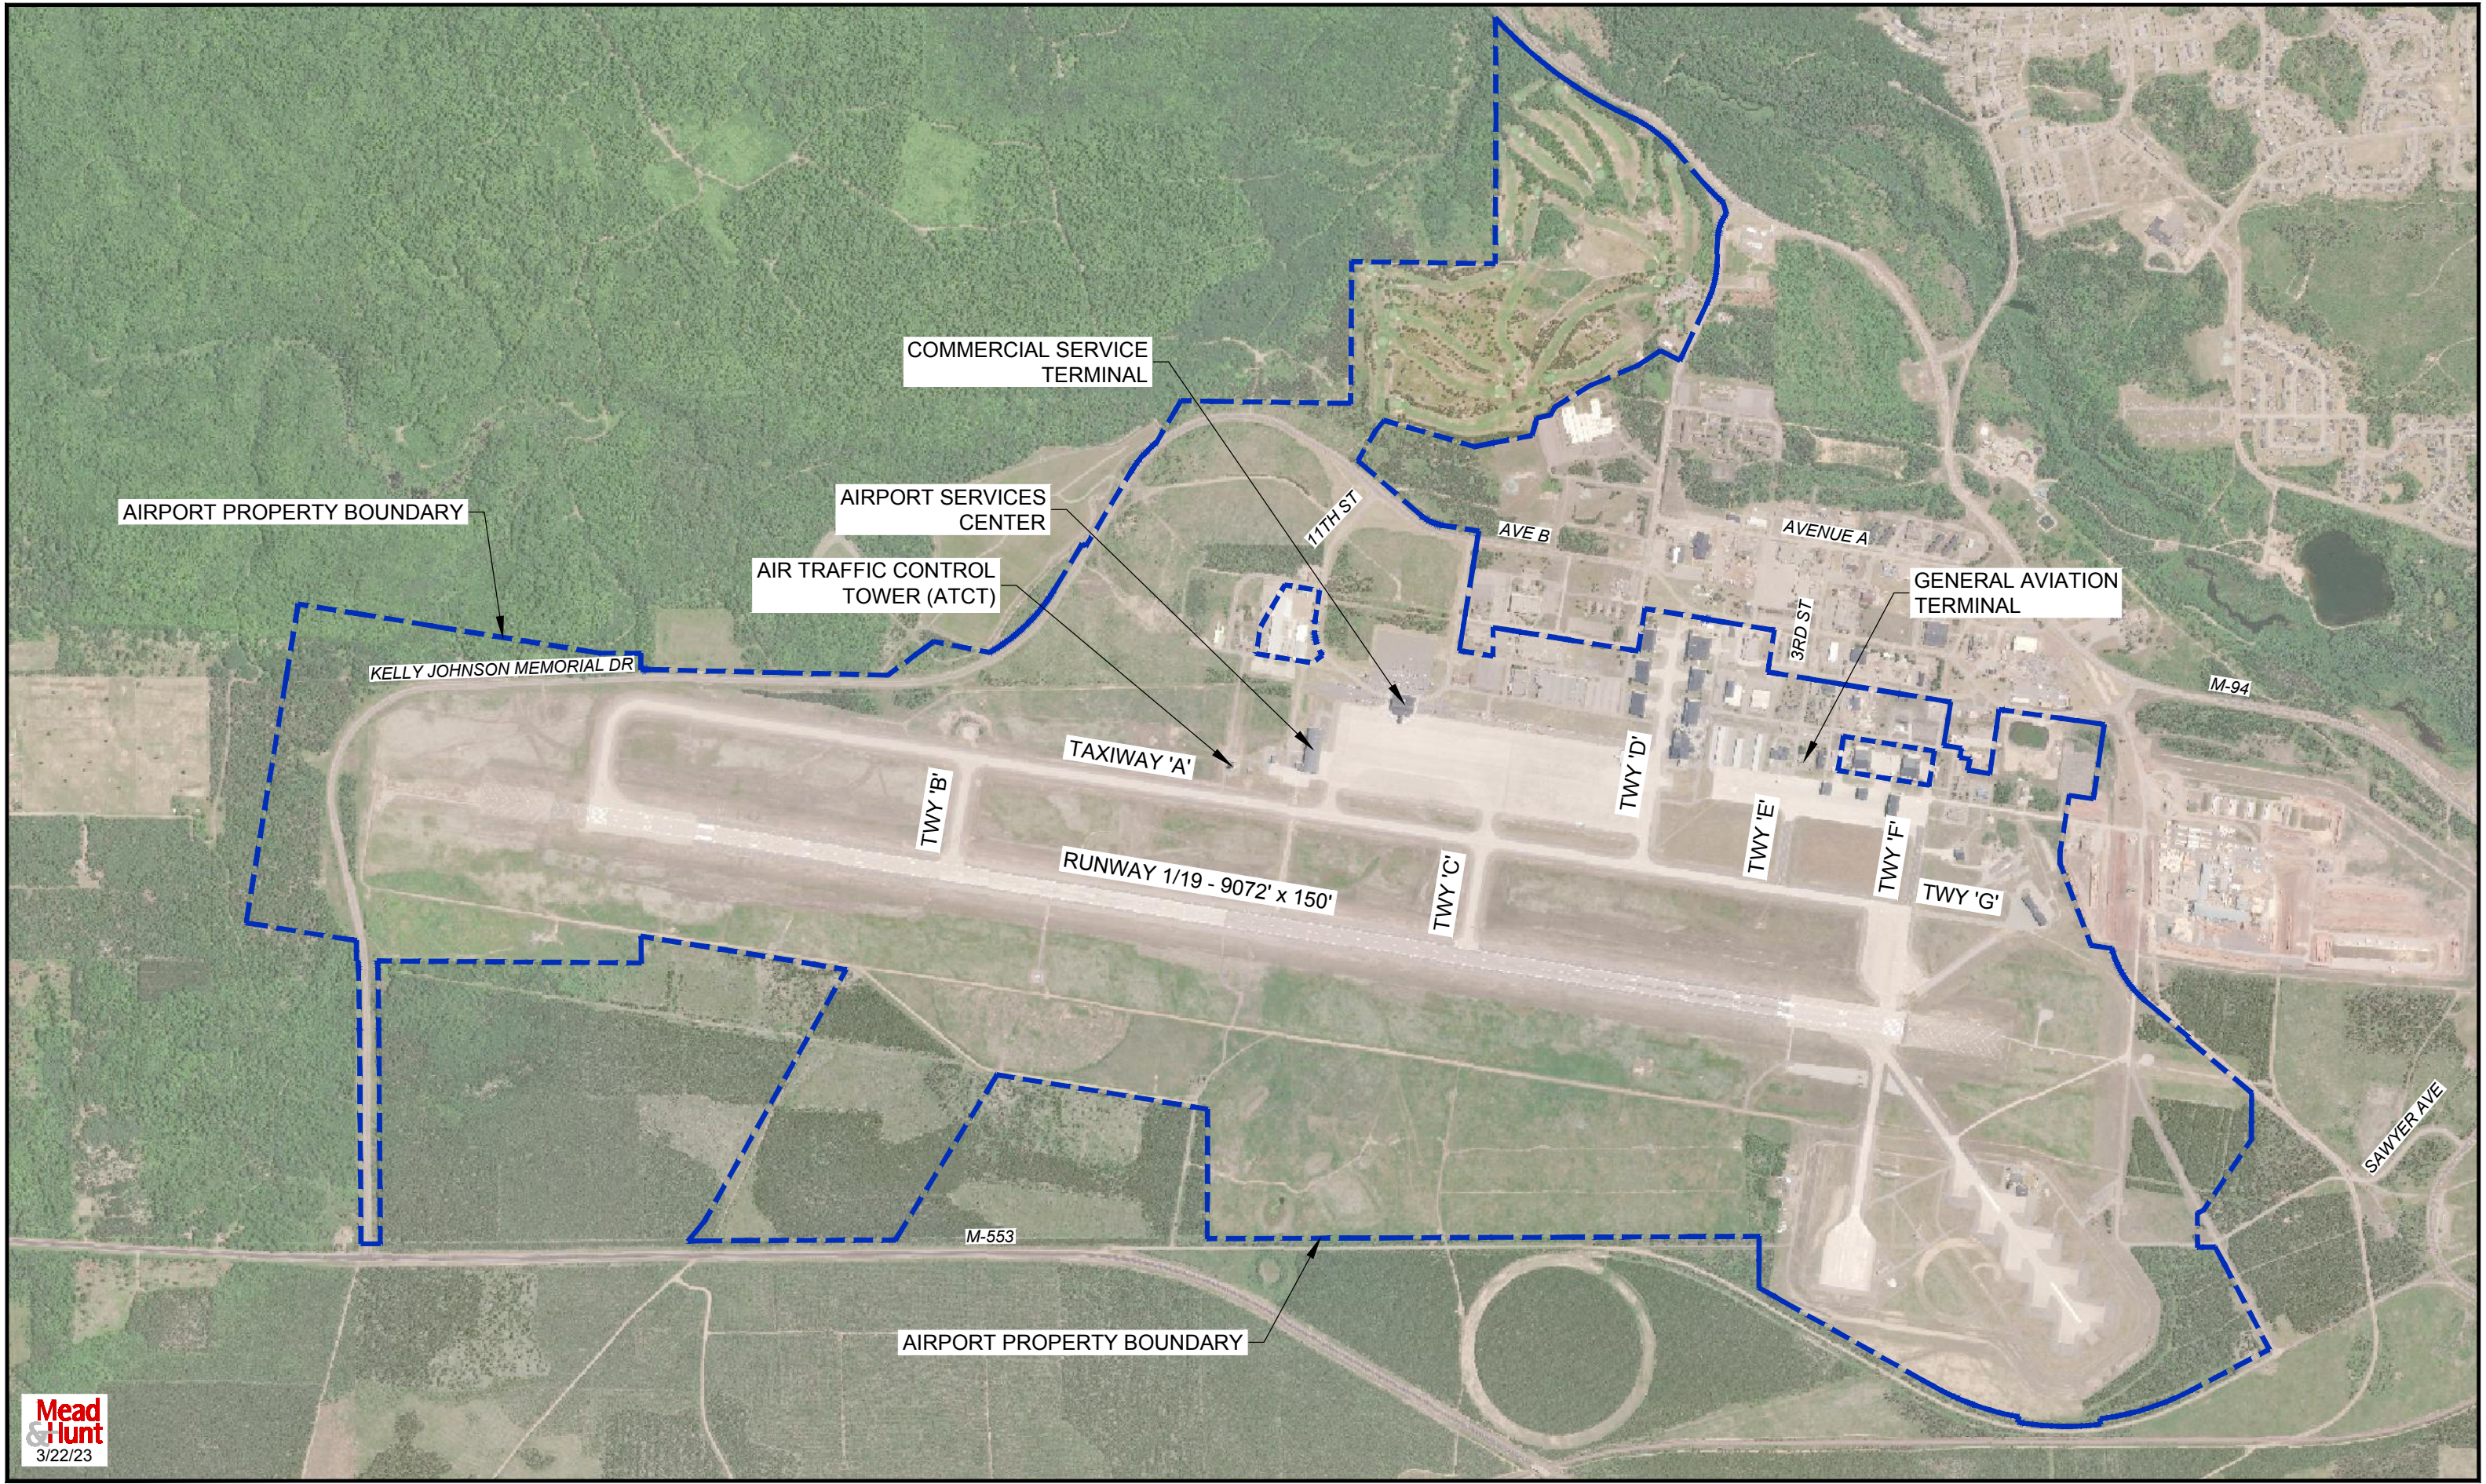
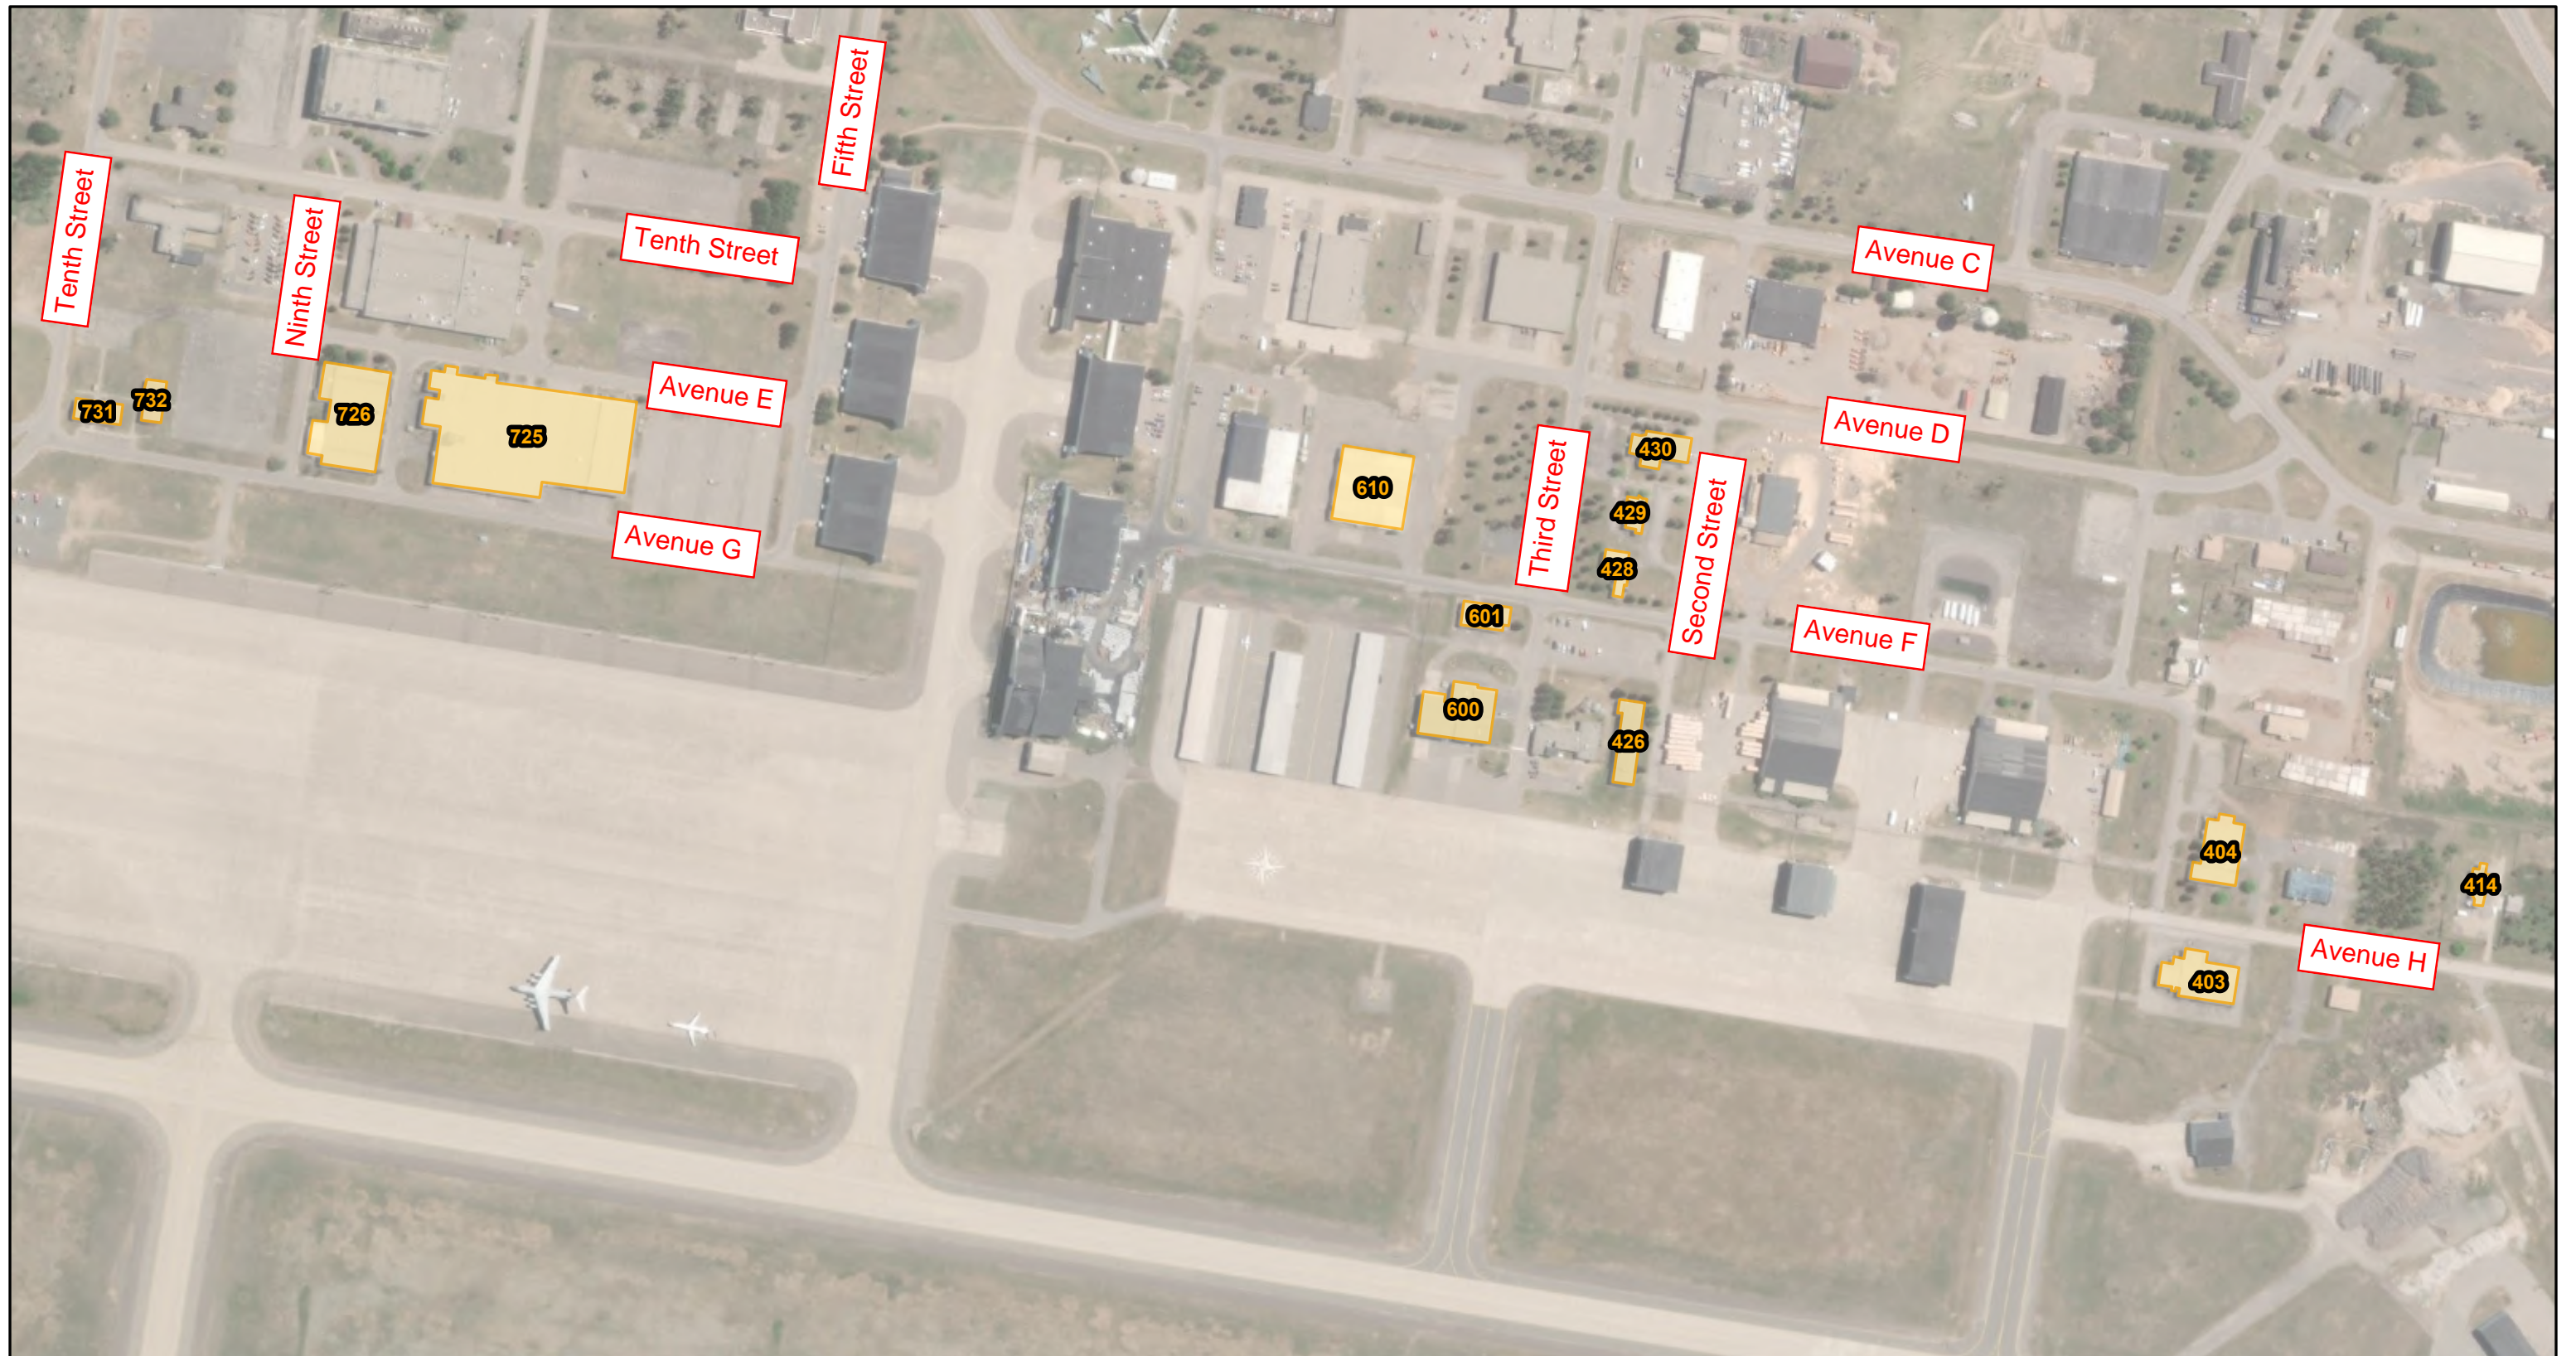
SITE DIAGRAM

Building Locations
GWINN, MI
